PRODUCT RECOMMENDATION PROGRAM

An in-depth product evaluation of both the Come-Up Seal Slim 12 and the Solo seal 9.5 conducted by the International Four-Wheel Drive Trainers Association (I4WDTA)

Product recommendation report: Come up Seal slim 12.5 and Solo Slim 9.5

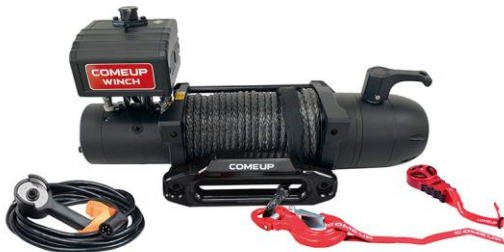
The Seal Slim 12.5 winch (left) is a Severe duty winch rated to 12,500 lbs. Equipped with a heavy-duty wound motor rated at 5.0 HP 3,730W. It has a hardened steel, 3 stage planetary gear train. It comes with a built in two-way digital signal wireless remote control and wired water proof remote control. The winch line is 12 strand construction synthetic rope coated to prevent abrasion. The housings are aluminum die cast built to withstand the 2X the load rating of the winch. The brake is an Automatic full load cone brake system. The gear ratio is a 3-stage planetary 225:1. The winch can be mounted foot forward or down depending on the user's needs.

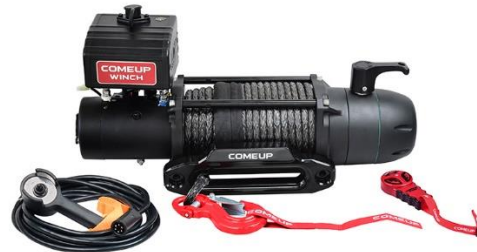
Solo Slim 9.5

The Solo Slim (right) has all the same above except the gear ratio being 159:1. The Solo Rs 12.5 has same features except the option of a modular control box for remote location.

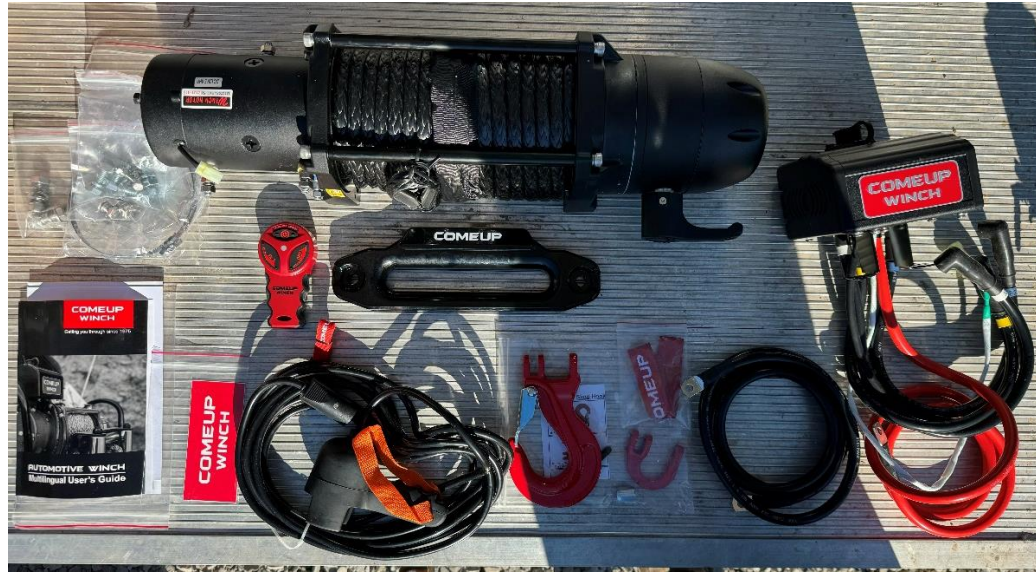
All Items and accessories included with the Seal slim 12.5R

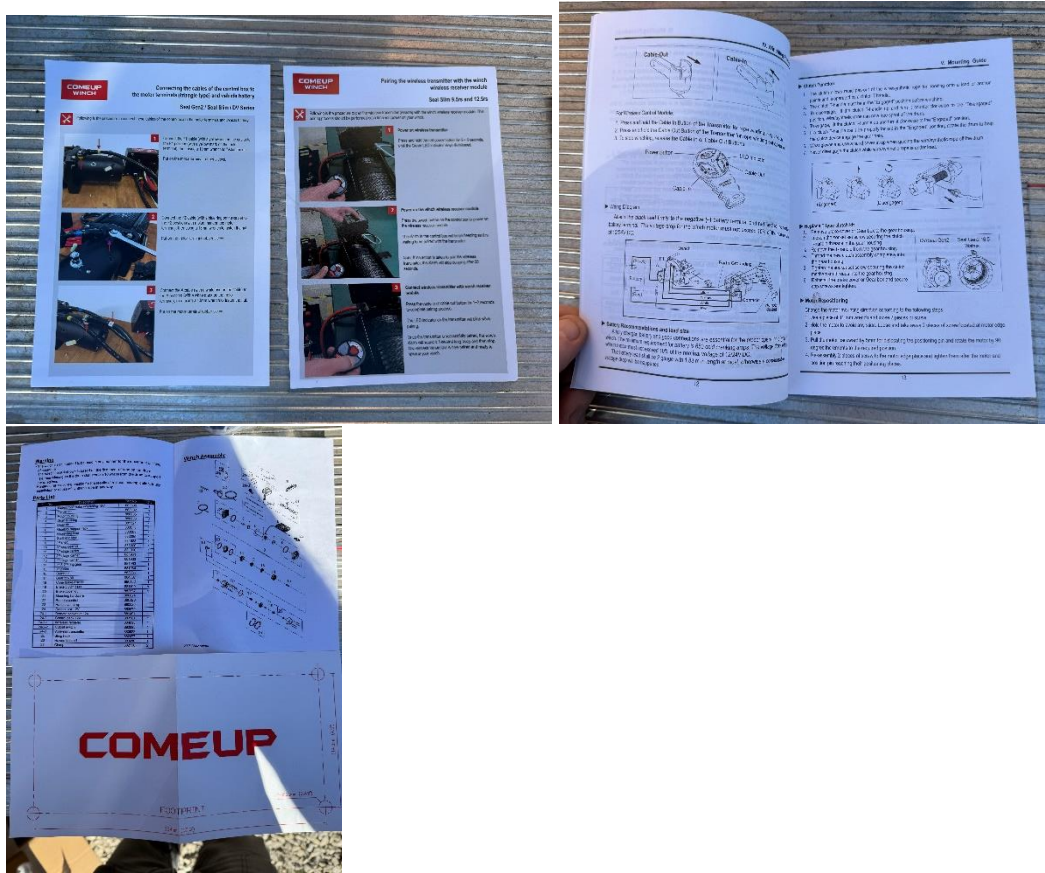
The Installation instruction, user manual and set up instructions.

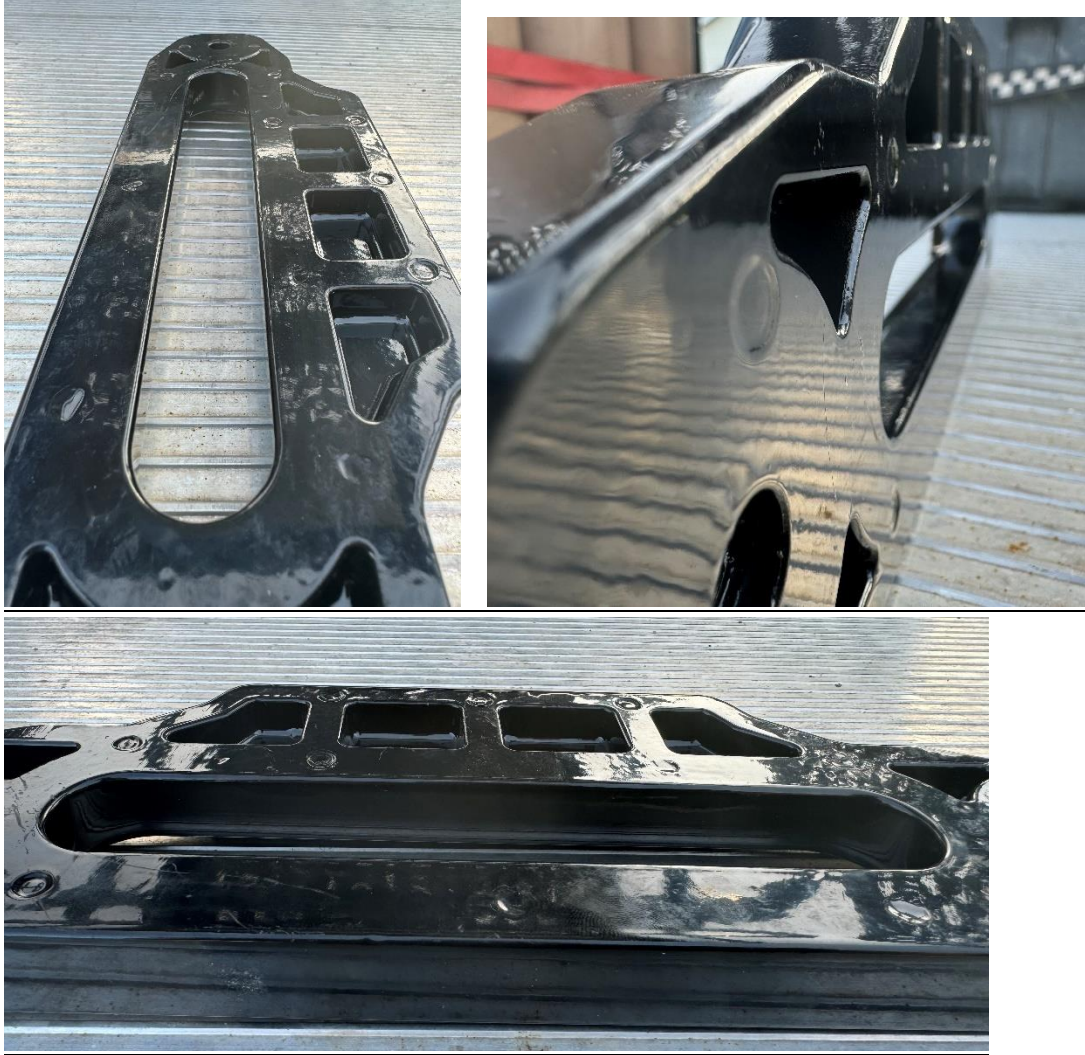
Hawse Fairlead:

Prior to installation the minimal amount of radius on the back side where the fairlead is chamfered was noticed. Due to concern of line damage Two winch samples ran the Come up fairlead. A standard delrin roller fairlead and a Hawse pro roller fairlead were used by the other two instructors for comparison.

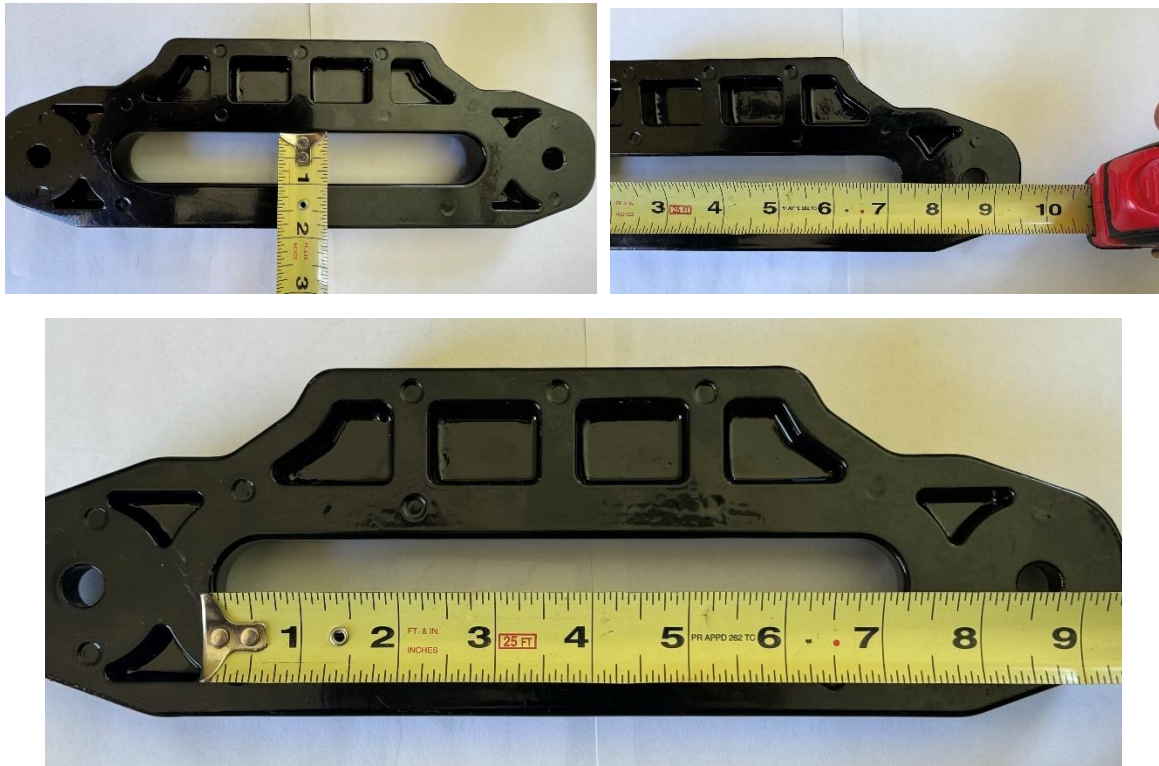
Another contributing factor to the rapid wearing of the winch line is the measurements of the opening on the Hawse fairlead. The width of opening is $7 \frac{1}{4}$ on a 9 inch drum. The difference in this opening to the drum is significant enough to cause a sharp angle when the line is at either end causing the winch line to drag over the radius of the back of the fairlead.

The vertical opening is 1 inch which is very small and when combined with the amount of line on the drum causes the same effect of a steep angle being created when the line wraps increase on the drum. When the line is on the 1-3 layer the angle of the winch line is more straight on with the opening of the fairlead. As the layers increase 4-5 on the underside of the drum the angle becomes greater and causes the line to drag across the back side of the fairlead where it has minimal radius causing excessive wear.

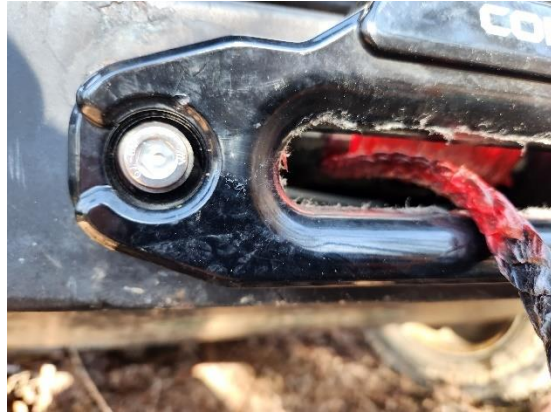
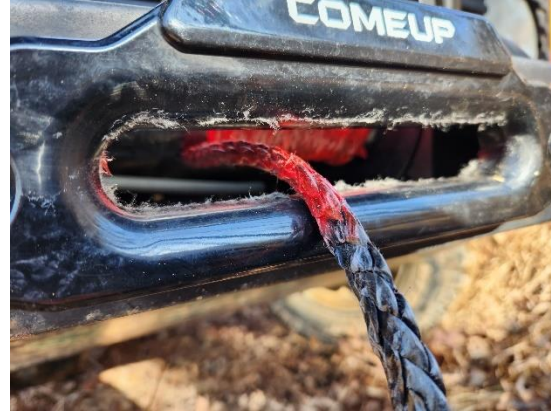
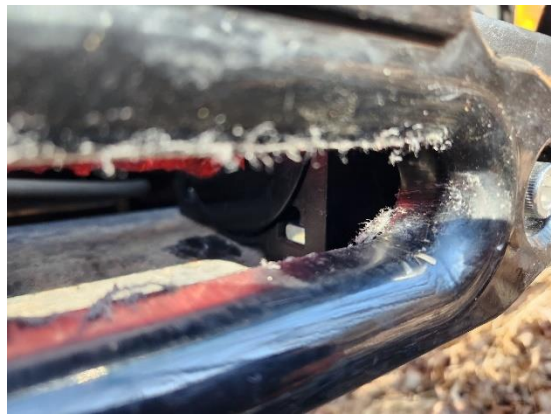
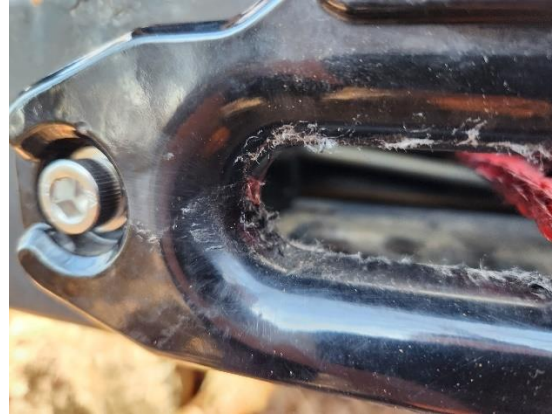
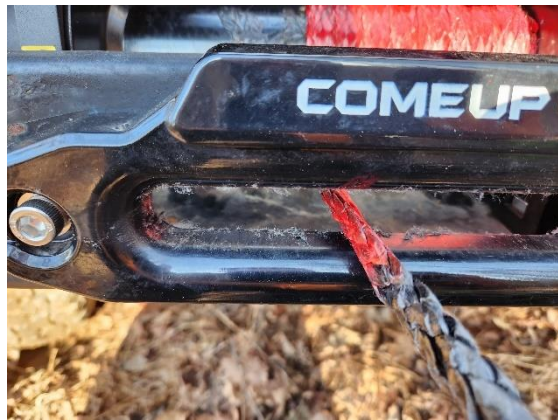
Hawse Fairlead: As can be seen in the pictures above on winch 1, the excessive amount of line material showing from the backside of the fairlead. The majority of the buildup and wearing of the line is occurring on the inside of the back portion of the fairlead. This amount of wear was seen after 4-5 uses during recovery.

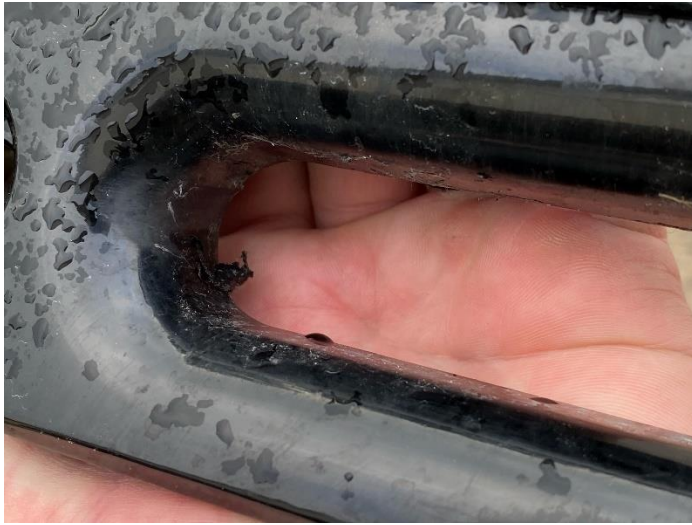
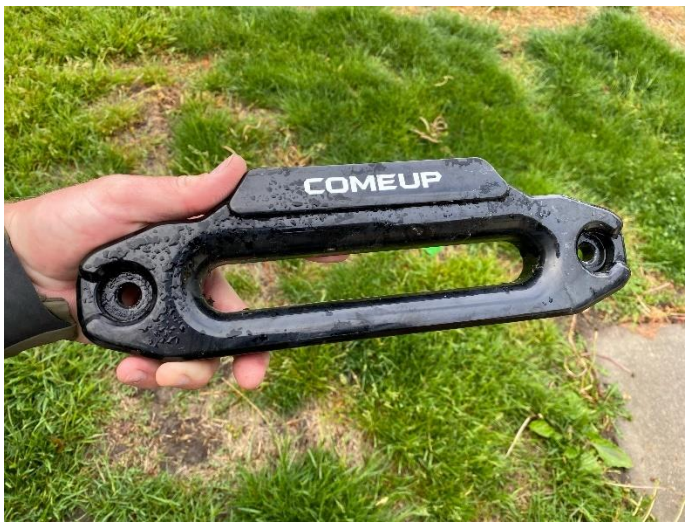
Winch 2:

Winch 2 was a winch that has been employed for long term use 11-12 months. It was observed early on the amount of wear on the winch line and it was replaced by a Hawse Pro roller fairlead. Notice the winchline material on the left of the fairlead.

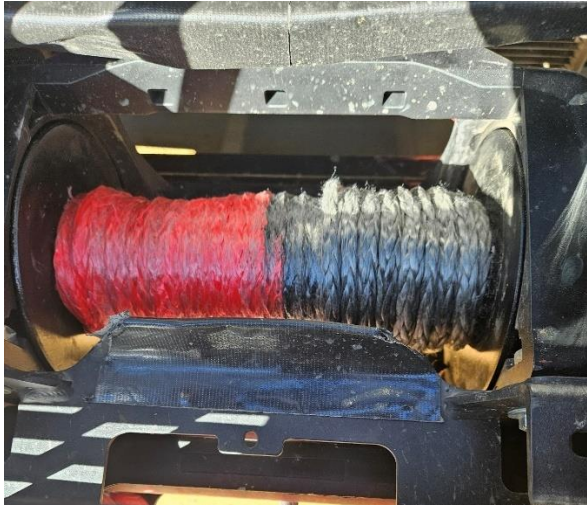
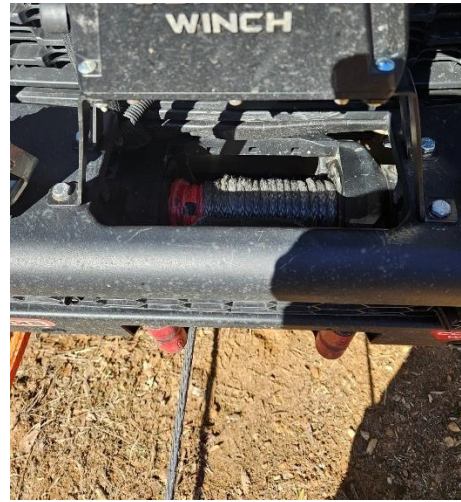
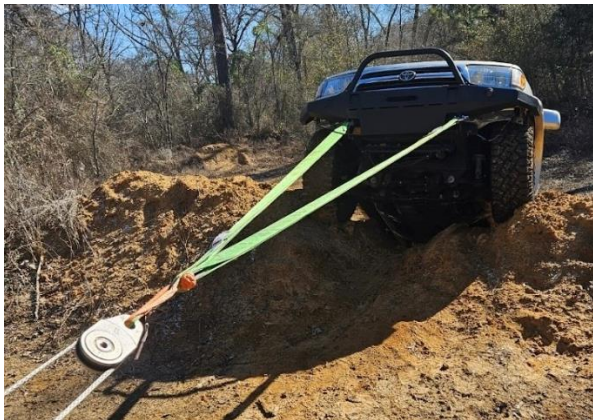
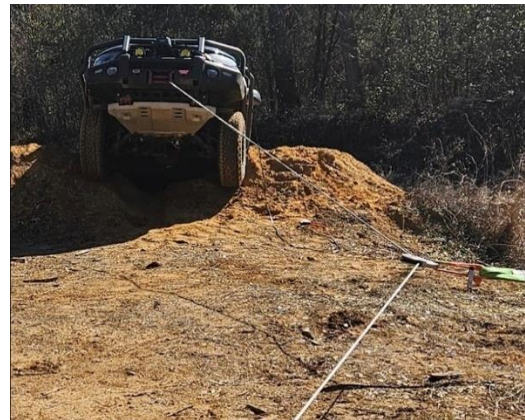
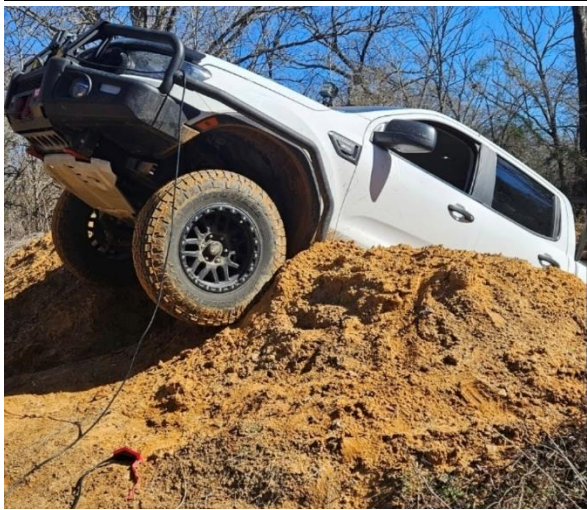
Hawse Fairlead: After a substantial amount of heavy usage as seen above during training and testing with harsh angles and loads one of the evaluators using a roller fairlead reported wear on the winchline but no failures, breakages or issues other than the line coming loose at the connection point where the line goes through the drum. Minimal wear and tear using a roller fairlead.

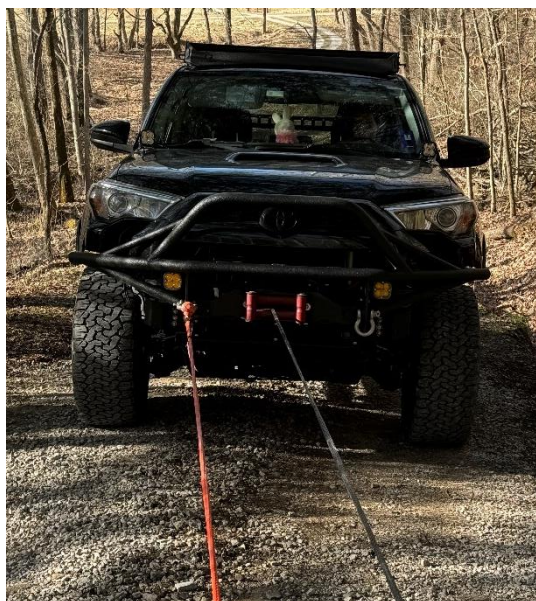
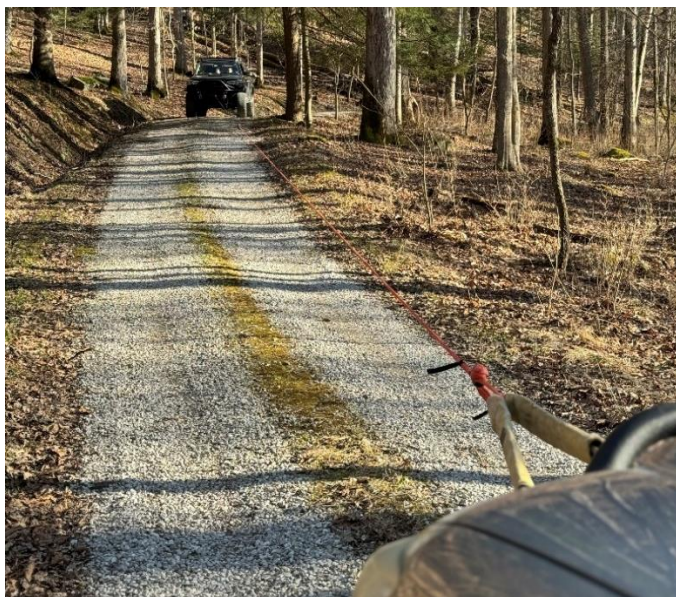
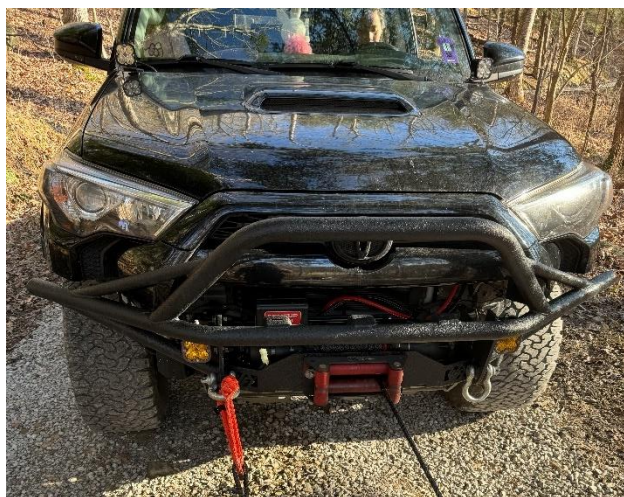
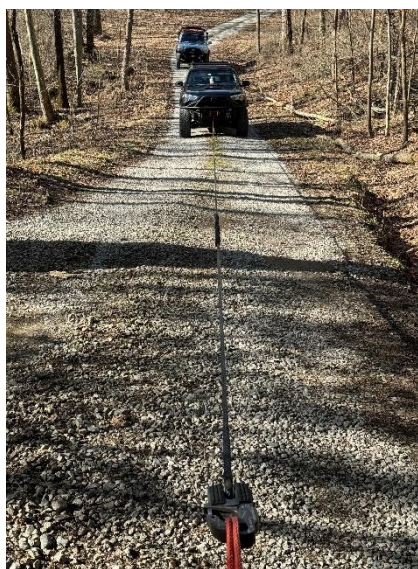
Hawse Fairlead: As seen above the other vehicle using a roller fairlead conducting typical self and second vehicle recoveries with angles under 35 degrees exhibited mild if any line damage or evidence of wear. The pictures below show the line post 22 recoveries conducted on the line using a Hawse Pro roller fairlead.

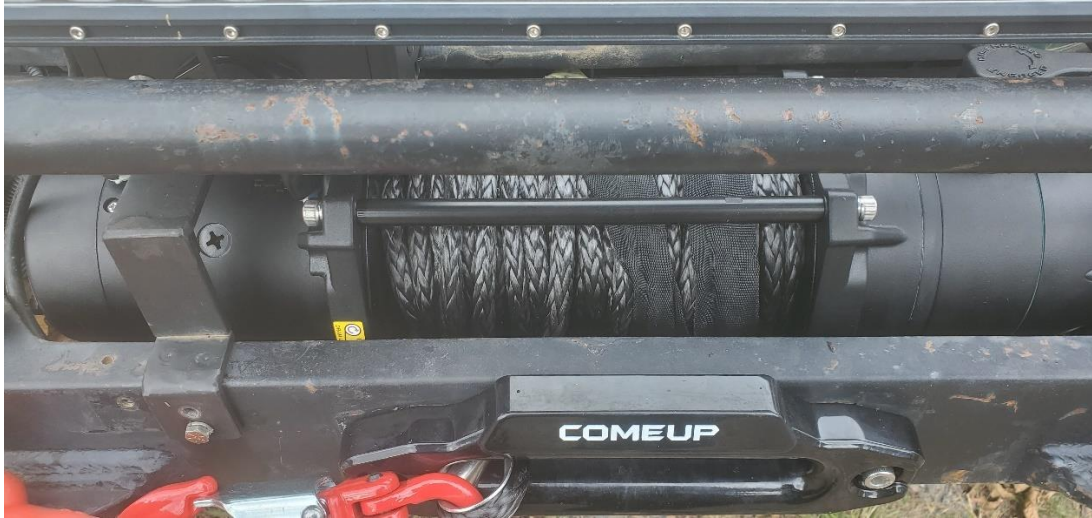
Land Rover

- Three other instances of the line breaking were located at the end of the line that runs through the hole in the drum. The line is constricting down on the portion of the line running into the hole on the drum. The line is being flattened onto the sharp edge of the hole cutting the line.
- The chamfer on the back of the hawse fairlead provided seem to not have enough radius and causes a lot of winch line material build up from coming through the fairlead accelerating the wearing of the line.

- One instructor had an instance where the line slipped off the drum while winching due to the way the line is installed on the drum. Between the silicon coating and the way, the line is installed on the drum this caused the line to continue to slide off when it was used on the first layer (11 wraps) during a recovery.

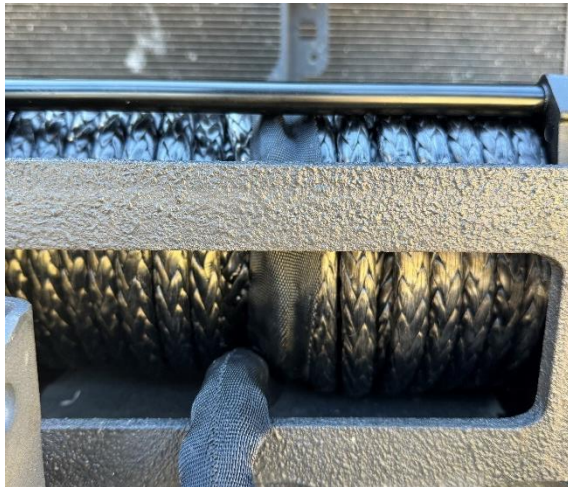
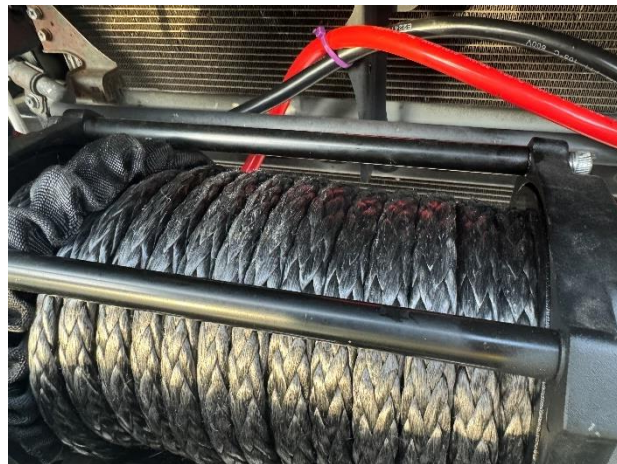
4Runner

in center line completely with the fair lead opening due to the additional length of the motor. The fleet angle from the winch to the back side of the fairlead opening was not directly in line. After review of the damages, it was determined these were the cause of the line damage resulting in the breakage.

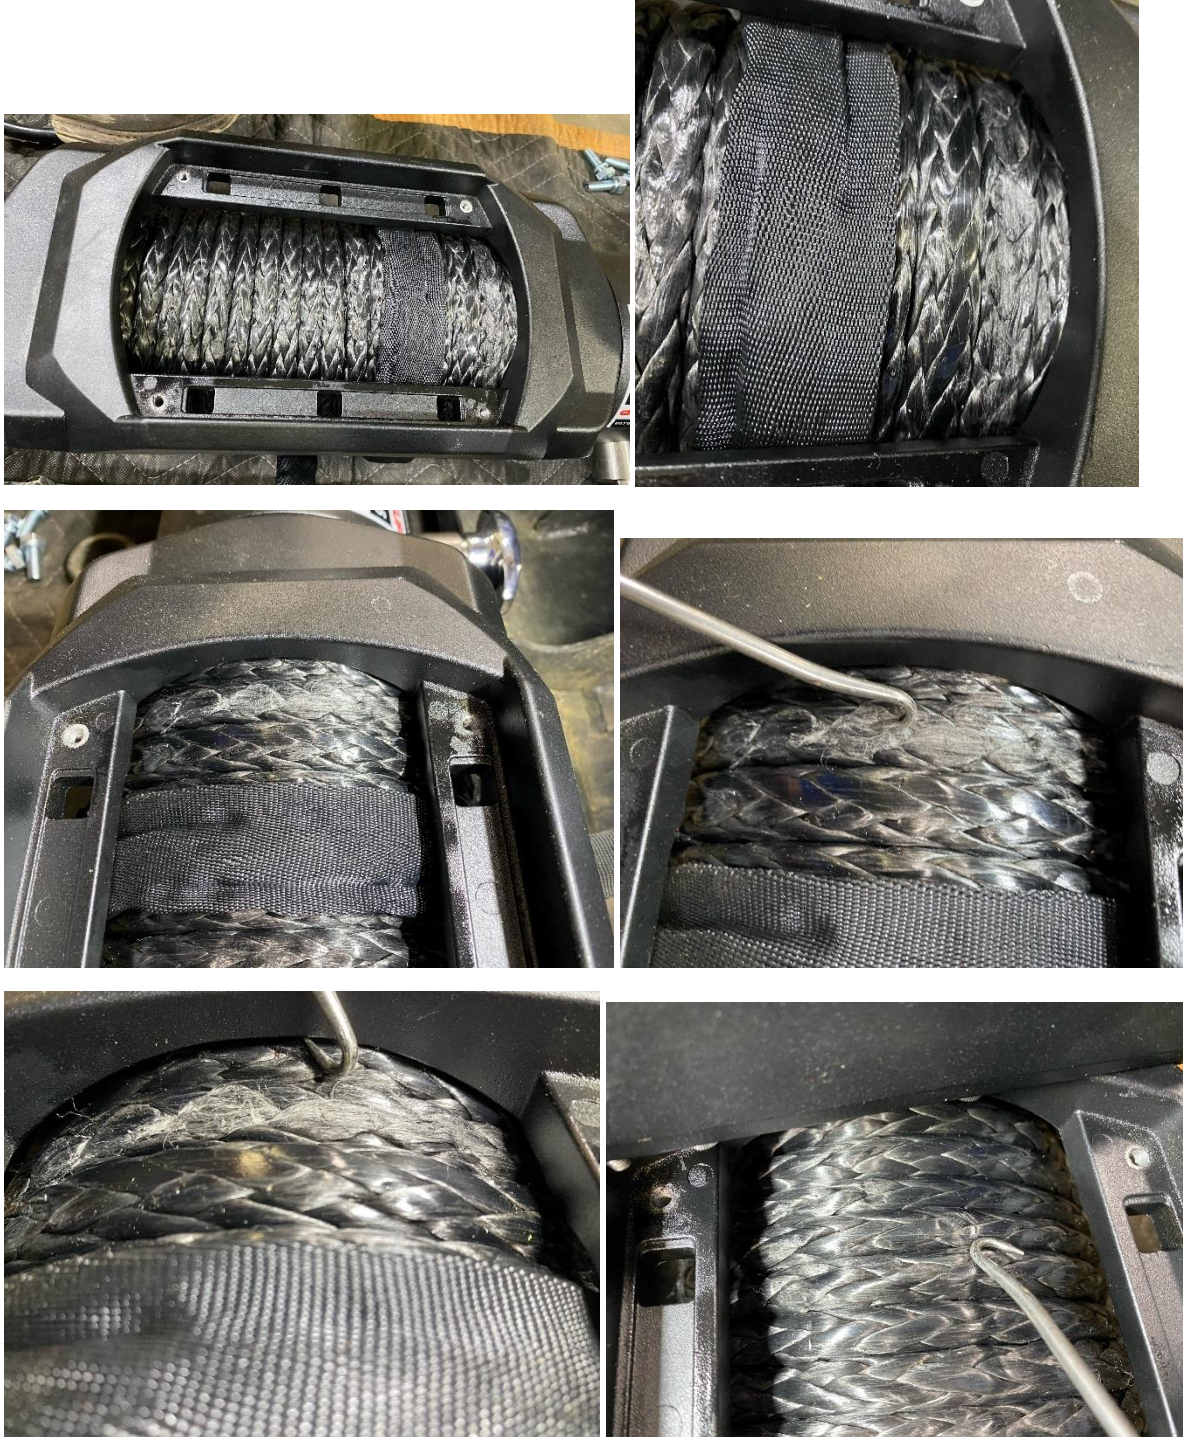
Toyota Land Cruiser

5. In the installation picture above, it shows damage present at installation on the Toyota land Cruiser. The damage appears to be from making on the crossbars and underside of the solenoid control box. The damage is due to too much winchline being installed on the drum. This amount of line on the drum does not allow for side loading and overlaying of the line and could cause winch line failures. The instructor reduced the amount of line down to 70 feet to conduct testing.

1. Identify the issues and correct the hard to pull out line via internal examination
2. Reduce the amount of line on the drum
3. Change the winch line installation method to the drum. (Constrictor Knot method)
4. Correct radius and centerline issues on the Hawse fairlead
5. Change or eliminate the recovery hook from the system.

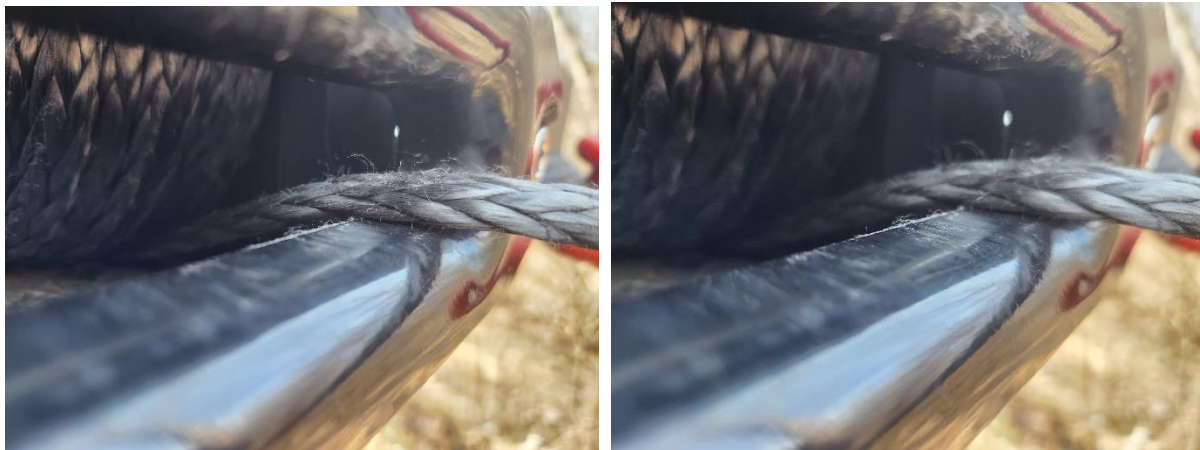
4. As seen on the hawse fairlead the winch line makes contact on the back of the fairlead at a steep angle when the line is drawn in and increasing with each additional layer causing damage to the line. See pictures below.

Example of the angles created when the line is on it 4-5 layer under load and receiving damage when running down the back side of the radius on the hawse fairlead.

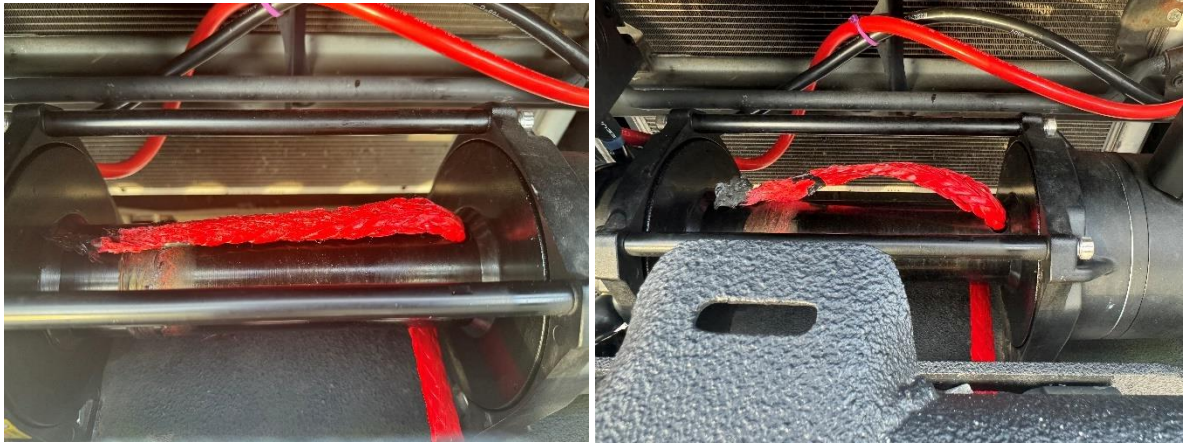
Winch Line:

The winchline is installed on to the drum via an old method remnant of steel cable. The synthetic line is run through a hole in the drum and secured by a hex key bolt running into the hole. During testing all four winches have a failure due to this method of securing the line to the drum. One winch (ford Ranger) had a line come completely off during a recovery, the line came completely through the hole and off the drum. The was remedied by the re installation of the line using a constrictor knot.

All for winches had some degree of line damage due of the line doing through this hole in the drum and the line being laid over flat cutting the line on the sharp inner lip if the hole.

- 1. Rope Length Adjustment:** The rope length will be reduced to prevent contact with the winch tie-bar, thereby minimizing the risk of rope damage.
- 2. Constrictor Knot Installation:** We will adopt the Constrictor Knot Method for rope installation, ensuring a more secure and reliable attachment.
- 3. Enhanced Free Spooling:** Improvements will be made to facilitate easier free spooling and effortless pulling out of the winch rope.

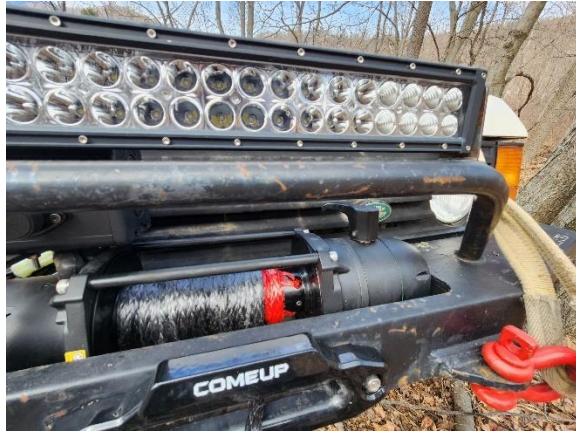
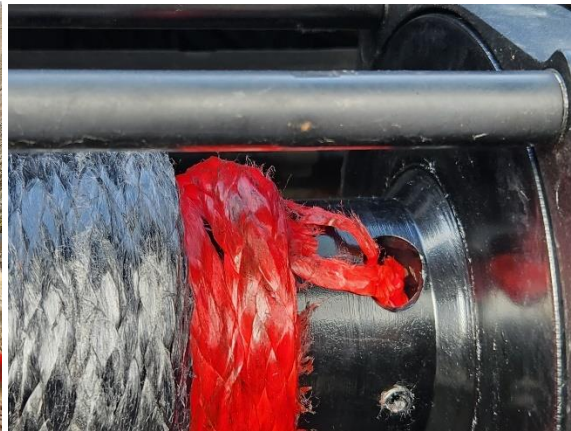
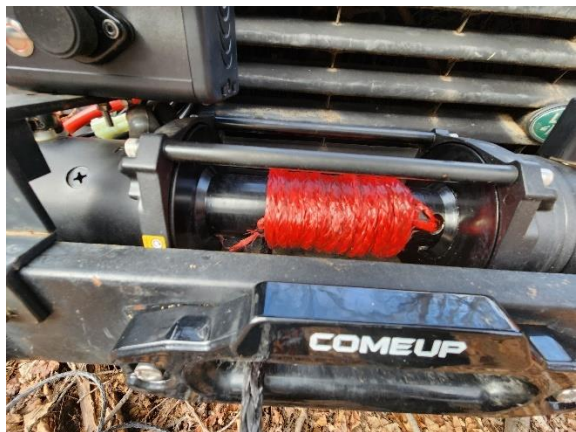
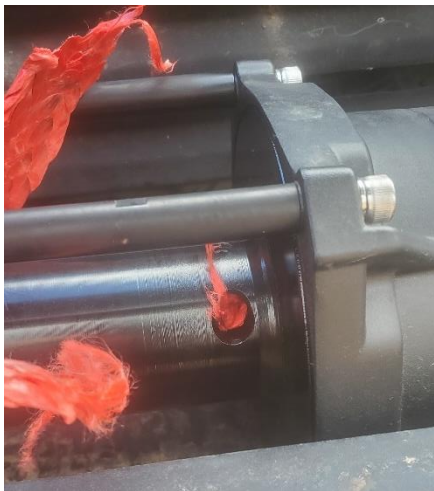
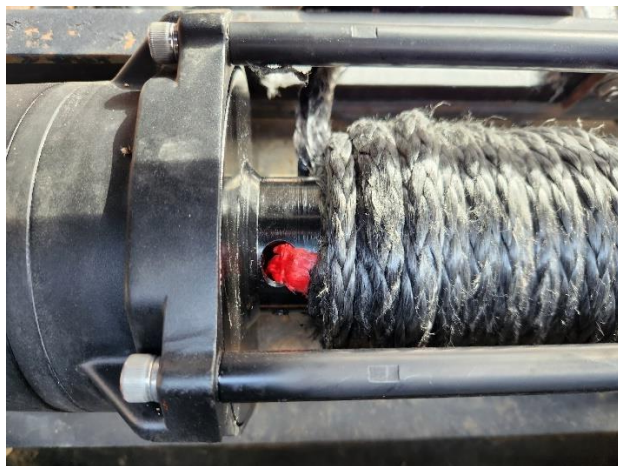
Land Rover: The Land rover had several breaks and re-instalaltions to complete testing. The land rover saw some of the highest loads during testing ranging up to 11,000 LBS

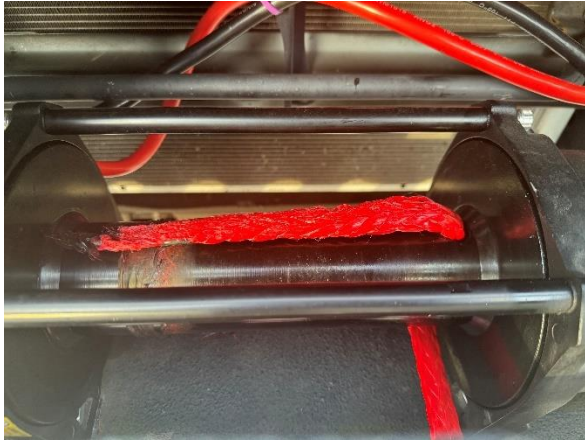
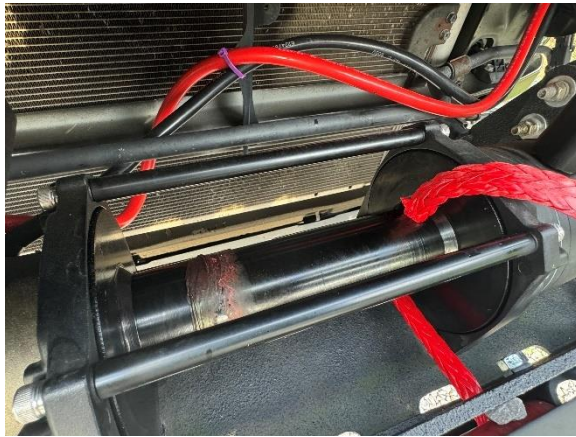
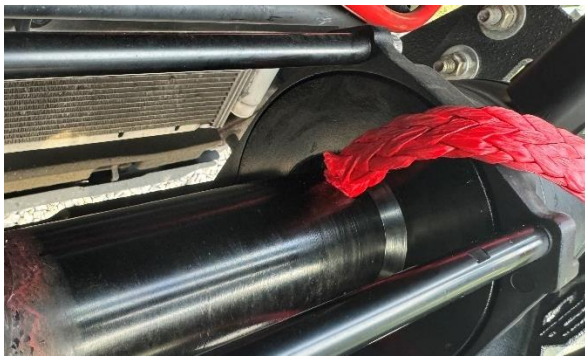
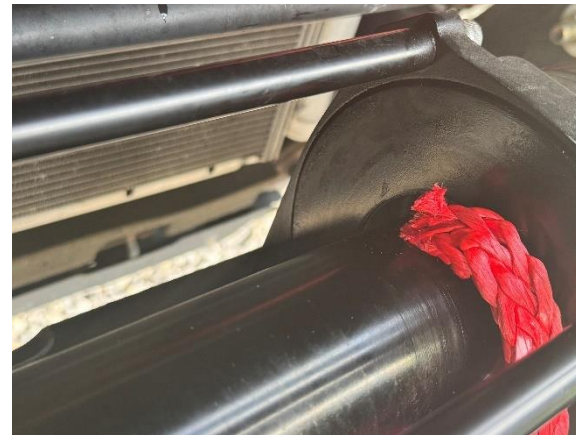
4Runner: Seen above is the start of damage on the line at the point where the line come out o fthe hole to start to lay across the drum. This is after 22 recoveries ranging from 6-7000lbs with moslty strait pulls using single line and double line pulls.

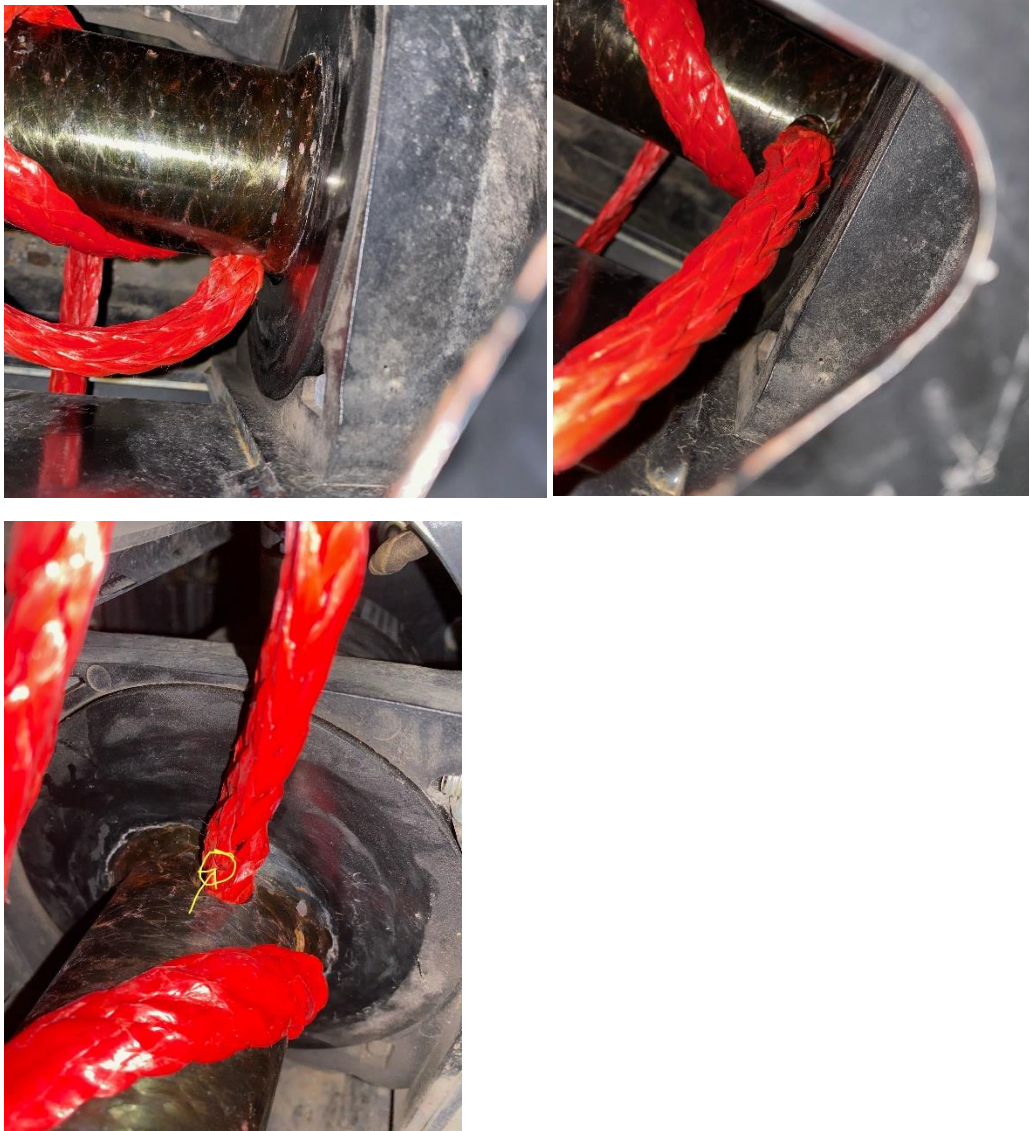
Toyota Land Cruiser: the lines show a cut in one of the braids and fraying of others. The Toyota Land Cruiser has been installed the longest and been used for training classes doing demonstrations of rigging and recovery procedures over the course of 10-11 months. Minimal loads ranging from 4-6000lbs.

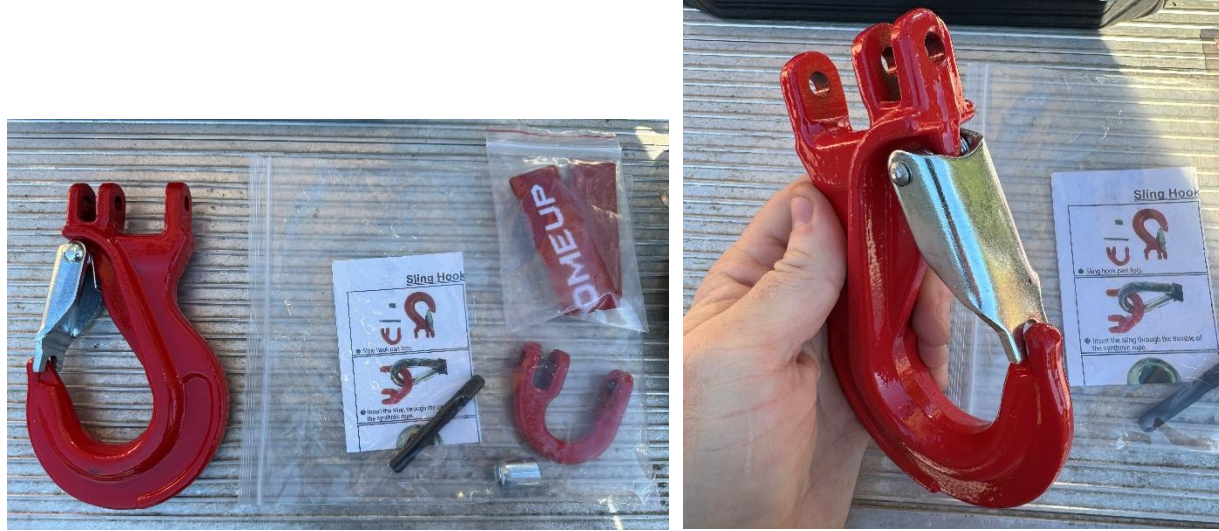
Winch Line Hook:

The metal hook included with the winch has a labeled rating of 6.5 tons. The issues with this item being included with the winch is that it is the most underrated item in the system and would be a potential failure point in the rigging. The winch is rated to 12,500 lbs and the line is rated to 21,600 lbs. During testing the winch saw recoveries with loads up to 11,000lbs. Due to the hook being rated to half the pulling capacity of the winch and less than 1/3 the load rating of the line it would be recommended to eliminate this from the equation to eliminate the risk of a failure during recovery.

The COMEUP Sling Hook is rated with a WLL of 3.15T. The WLL is calculated by dividing the Minimum Breaking Strength (MBS) of 12.6T (27,778 lbs.) by a safety factor of 4. The safety factor of 4 is defined by the hook manufacturer. The MBS of COMEUP hook is rated at 222% of the Slim 12.5 winch and 293% of Solo 9.5 winch pulling capacity. The COMEUP Sling Hook is appropriate for use with any winch with a pulling capacity up to 12,500 lbs.

This clarification of the WLL of the Hook provides a high degree of confidence in the equipment and is no longer viewed as an issue on the Come-up winch for safe recovery operations.
